Re: Creation Care Committee Report

The Creation Care Committee aspires to bring the church building into compliance with a Net-Zero Energy Plan.

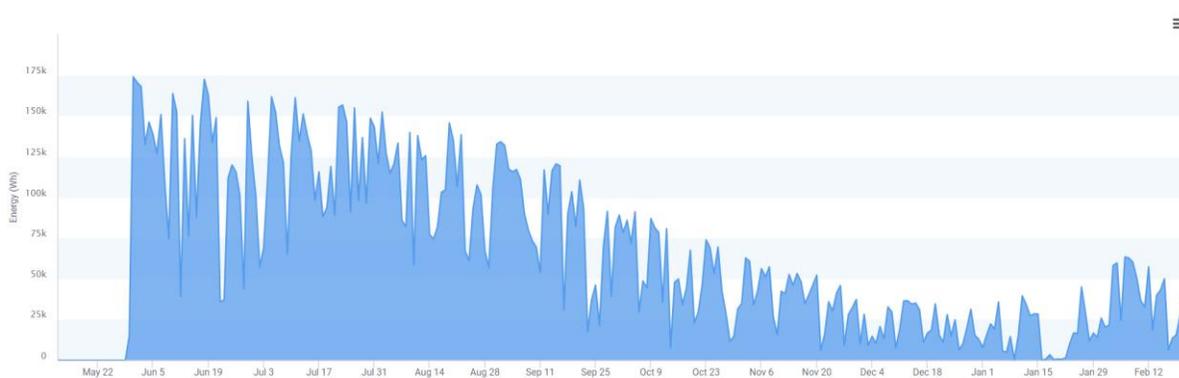
UMC Daily Solar Production to Date

Solar power project has a much bigger impact on energy costs than on energy use (GHG, EUI or the ESTAR score). Solar power isn't considered "free energy" in this tracker, and we don't get "credit" for the electricity the system produces and sends to the grid (we do get "credit" from the utility company, thankfully!). Since

the system came online in June 2023, we have generated 14,000 kWh of energy; extrapolated to a full year, this means \$3,100 worth of electricity and the equivalent greenhouse gas reductions of taking 4 ½ automobiles off the road.

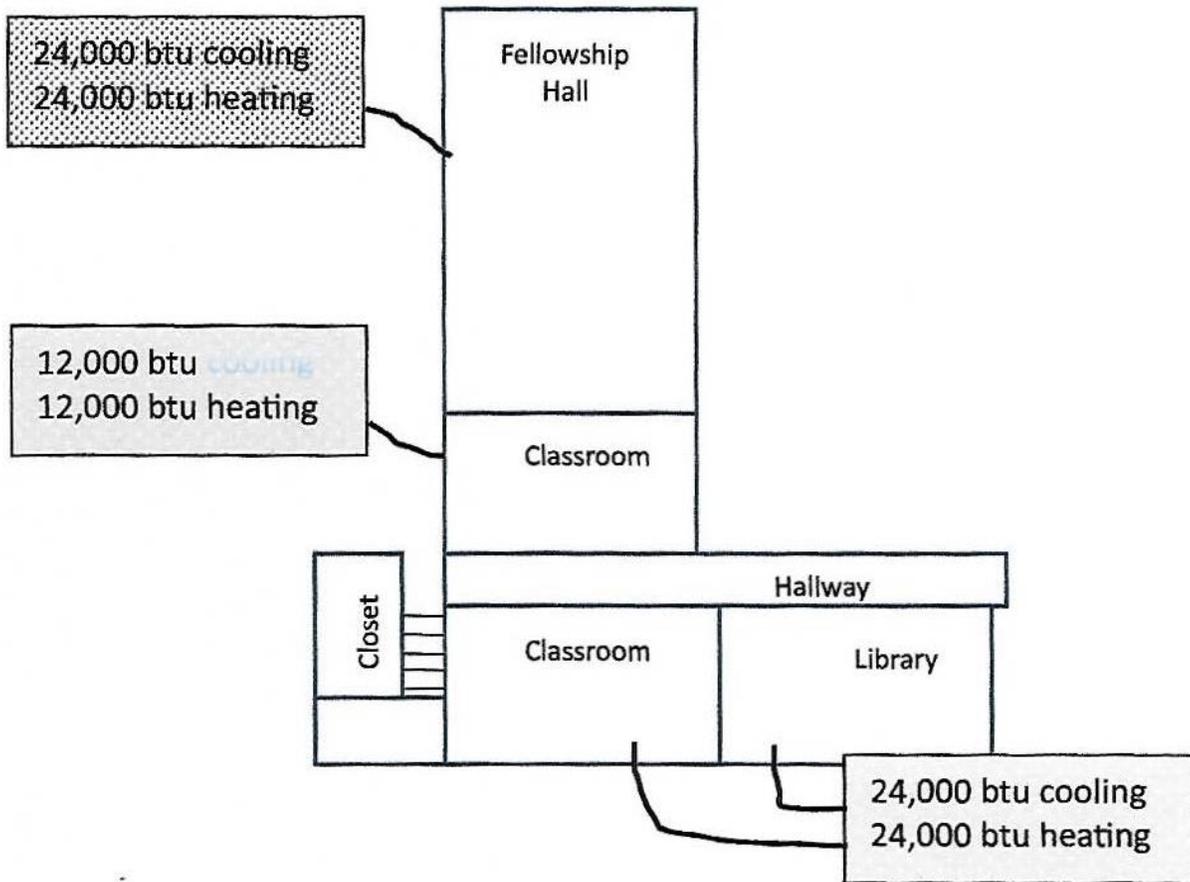
**Integrity High Efficiency Heat Pump Proposal \$23,000**

- 1-24,000 btu head in Fellowship Hall
- 1-12,000 btu head in North classroom
- 1-12,000 btu head in South Classroom
- 1-12,000 btu head in Library

As shown in the illustration, this approach would involve the installation of three outside heat pump units and four inside wall mounted heads. All units carry warranties of 12 months for parts and 1 year for labor.

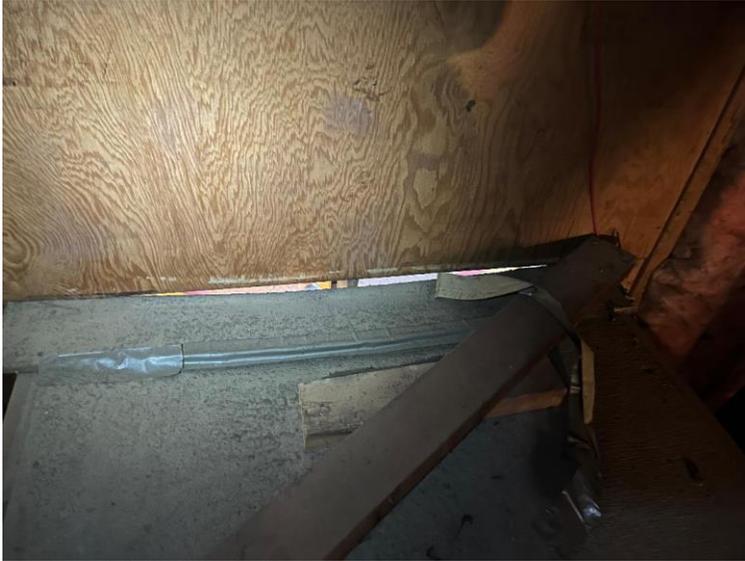
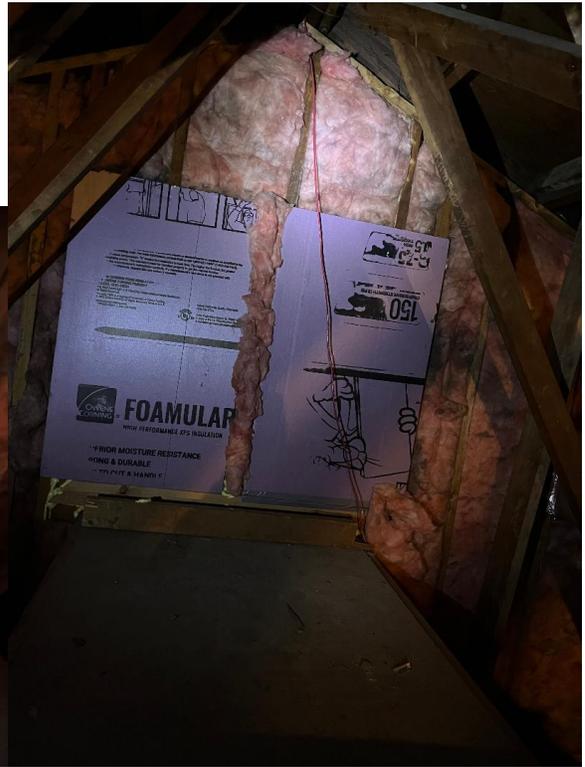
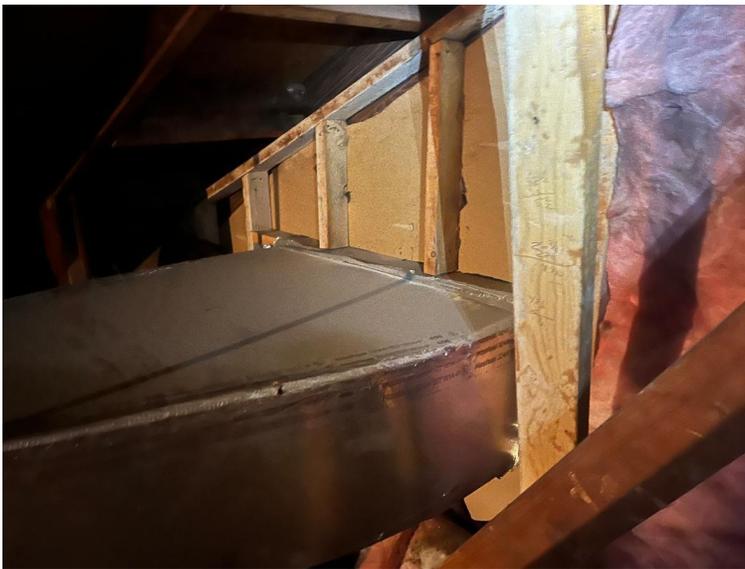
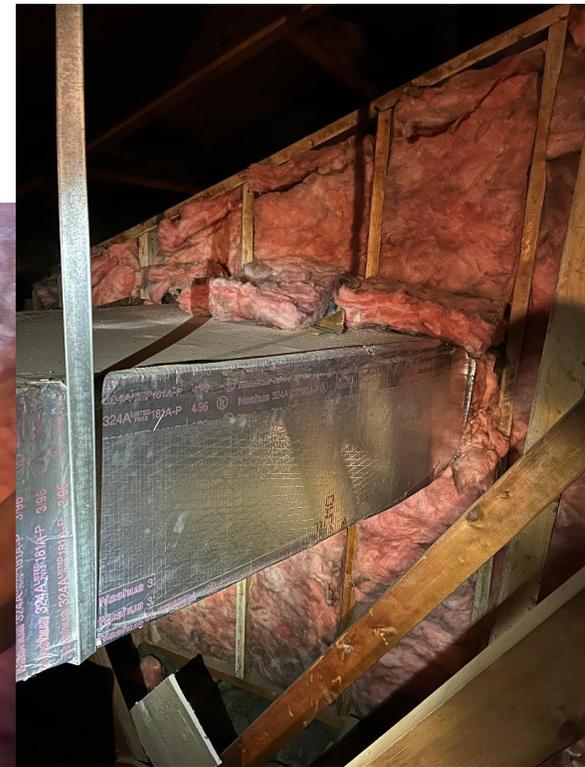
Some Before and After Photos of Church Attic

Insulation: Matt Rooke inspected the attic adjacent to the sanctuary and found multiple areas of heat loss that needed insulation. He recommended the following:

- 1) Secure and air-seal the exhaust fan duct connection to the sanctuary grille. There was a big gap and should be the priority.
- 2) Insulate the back of the plywood panel behind the exhaust fan grille.
- 3) Replace the batt insulation where it has fallen down on the wall between the attic and sanctuary.
- 4) Air seal any small gaps or penetrations in ceiling between attic and foyer/classrooms and make sure insulation is in place.
- 5) Cut access from the side attic into the attic behind the altar/stage area. Make sure all insulation is in place (identified at least one big gap missing area through IR camera).

On January 24<sup>th</sup>, Matt, Marvin and Jim completed the identified insulation work (See some before and after photos below—additional photos can be viewed upon request). Matt reported that it’s hard to calculate exactly how much energy savings would be realized. However, since they were able to close some significant gaps from the sanctuary to the vented attic and replace a good bit of the insulation that was out of place, he estimates an approximate 4% of heating energy savings. Marvin added insulation behind the stage in the front of the sanctuary, which should also save some heat loss. These combined efforts are getting us a little closer to net zero, but to reach that goal, where possible, we need to replace our resistant heat sources with high efficiency heat pumps.
